King George Playing Fields

Inspection Ref: 2269786

Operational Inspection - 18-January-2024 - 09:16 Inspector Matthew Meredith

Risk Assessment: 12 Moderate Risk

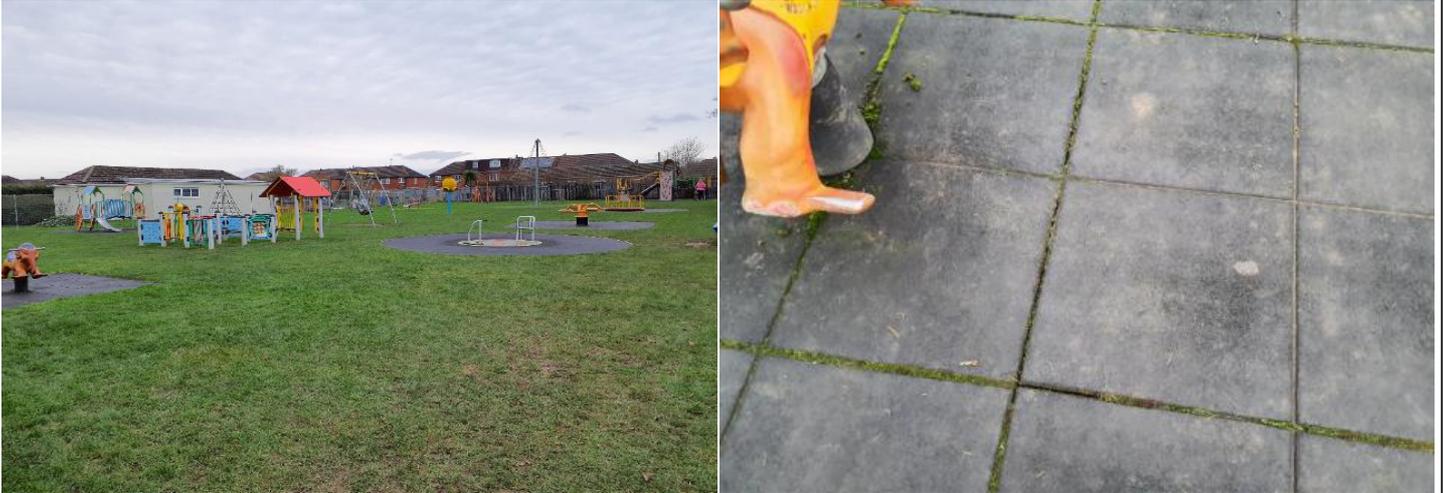
Finding: There is algae or moss growth on the tiled surface resulting in slippery conditions
Action: Clean and treat appropriately

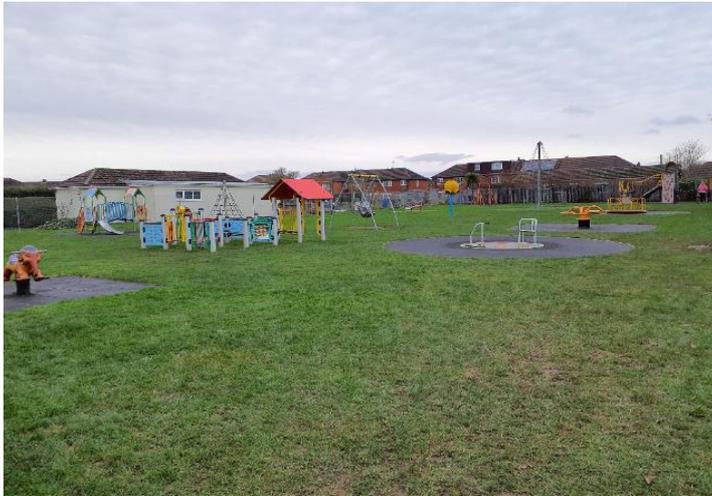
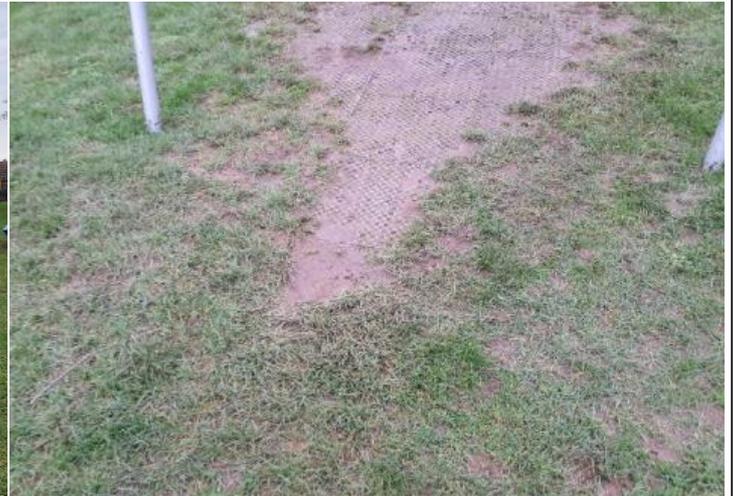
Finding: The grass mats are silted up and the soil is compacted; this may have an effect on the impact absorbing properties of the surface

Action: Consider HIC testing impact absorbing properties to ensure the correct surface qualities are maintained for the equipment and replace as required

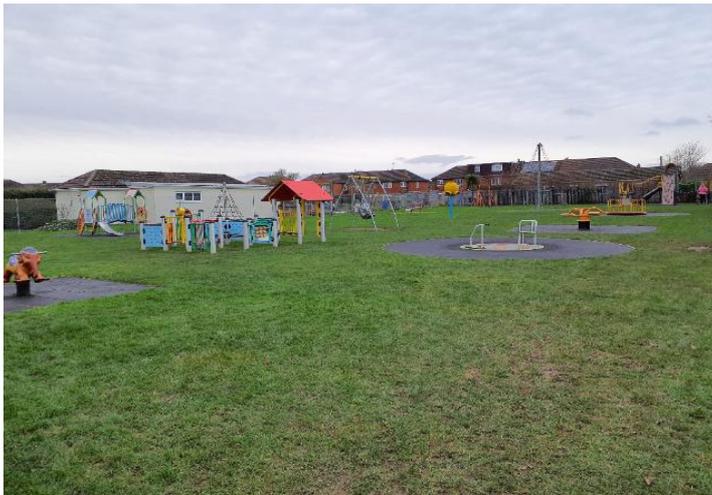
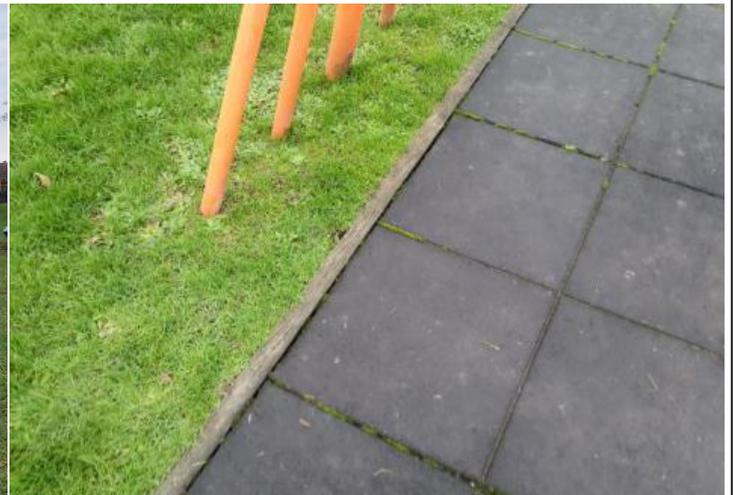
Finding: There are gaps opening in between the tiles

Action: Monitor for any further deterioration and repair as required

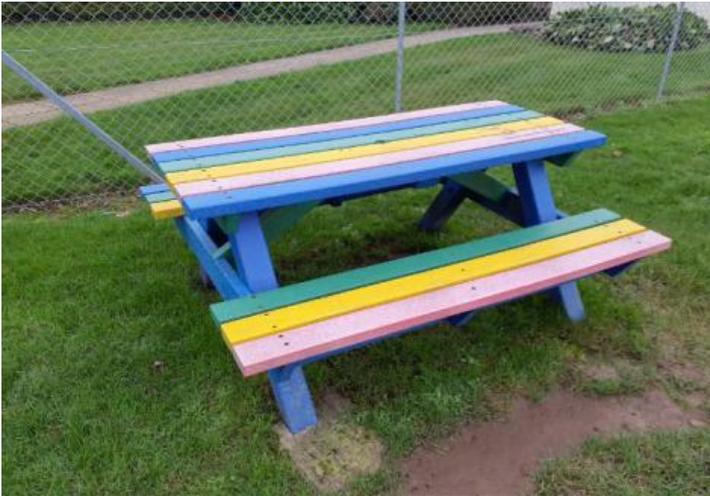
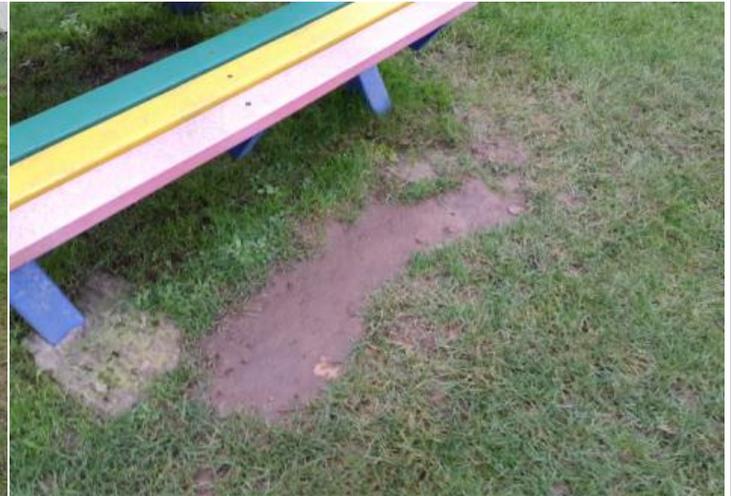
Finding: The area around the item has eroded and may become slippery	Action: Reinstate eroded area
---	--------------------------------------

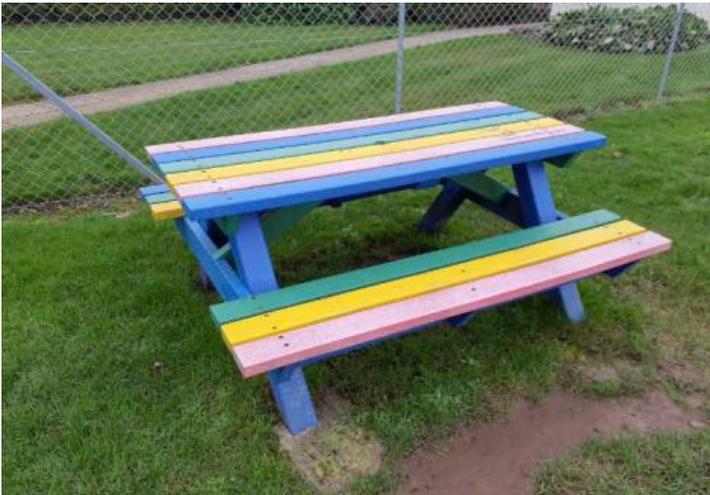
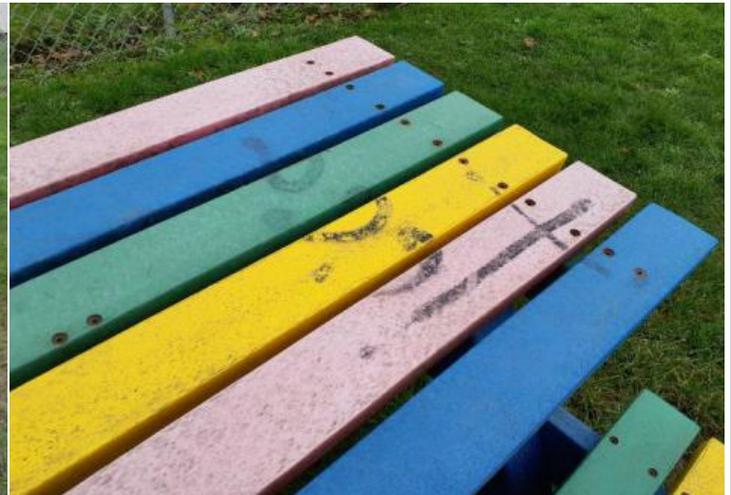
Finding: There is some graffiti present	Action: Remove the graffiti
--	------------------------------------

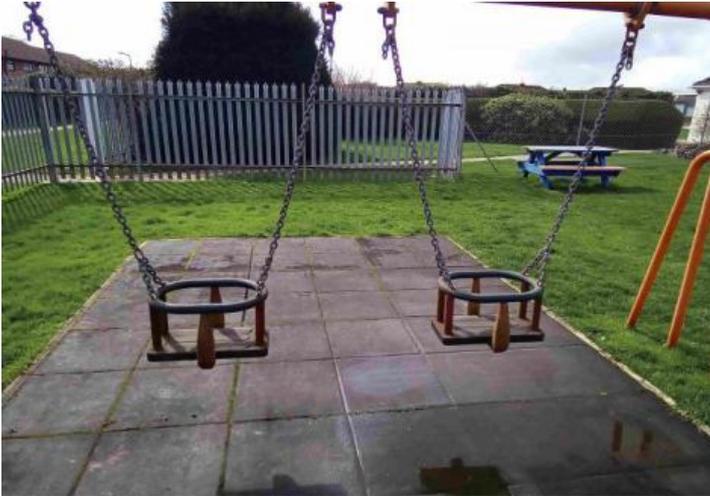
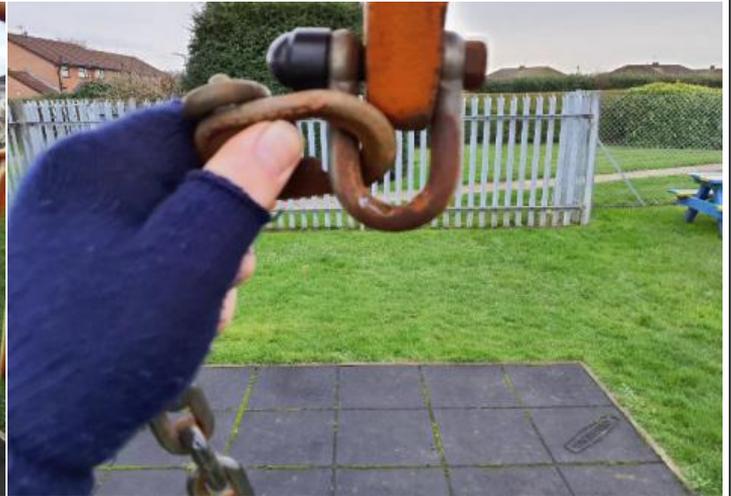
Finding: There is some wear to the shackles.

Action: Monitor for any further deterioration and replace when 40% worn

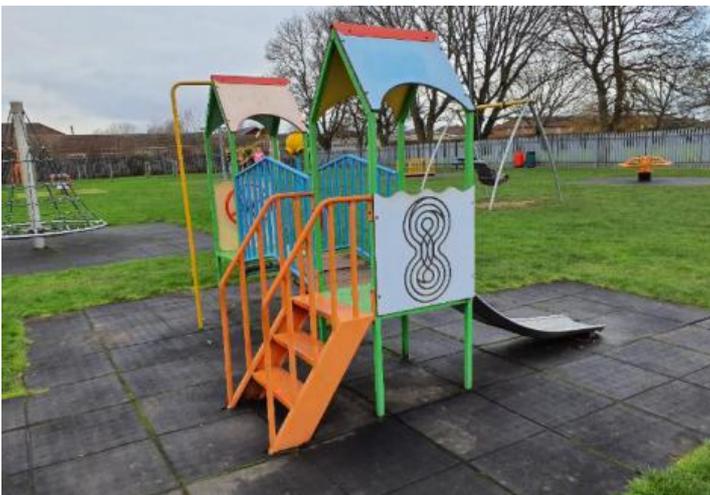
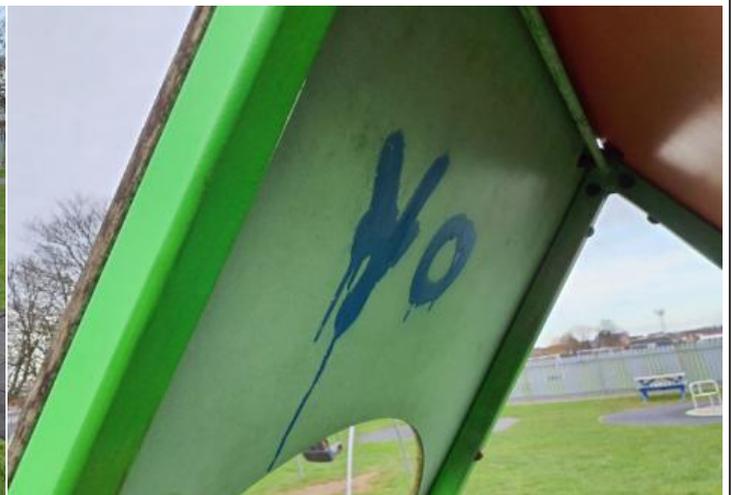
Finding: There is some graffiti present

Action: Remove the graffiti

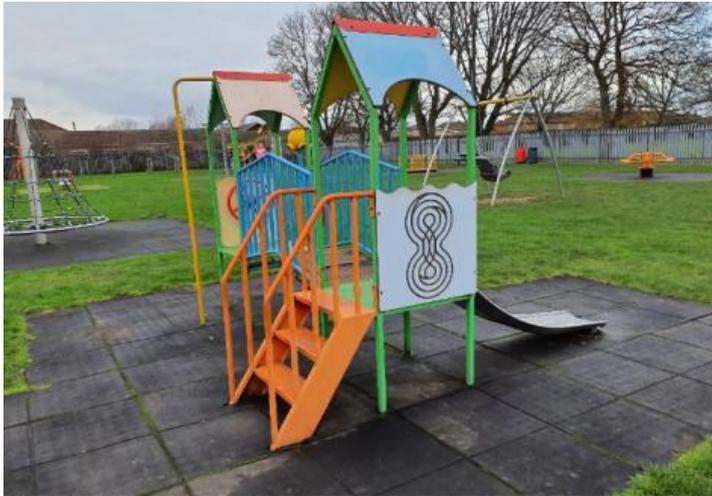
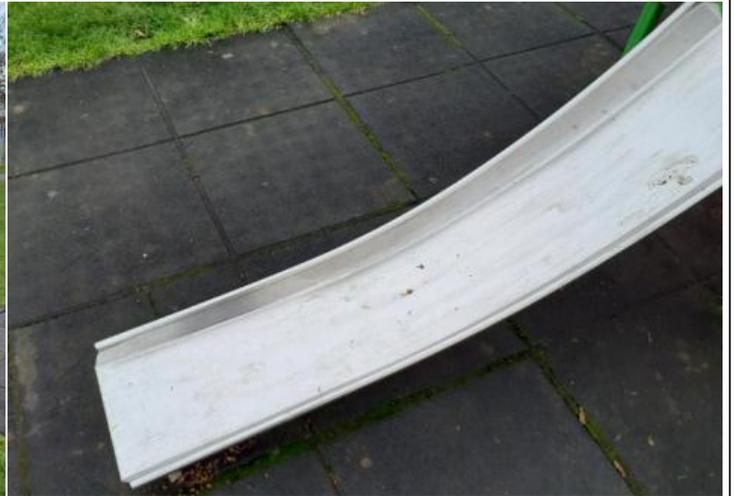
Finding: There are a number of dents in the slide surface

Action: Monitor for any further deterioration and repair as required

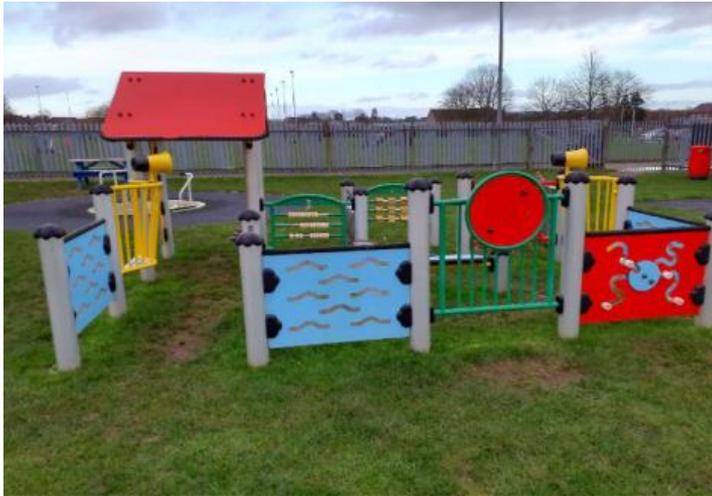
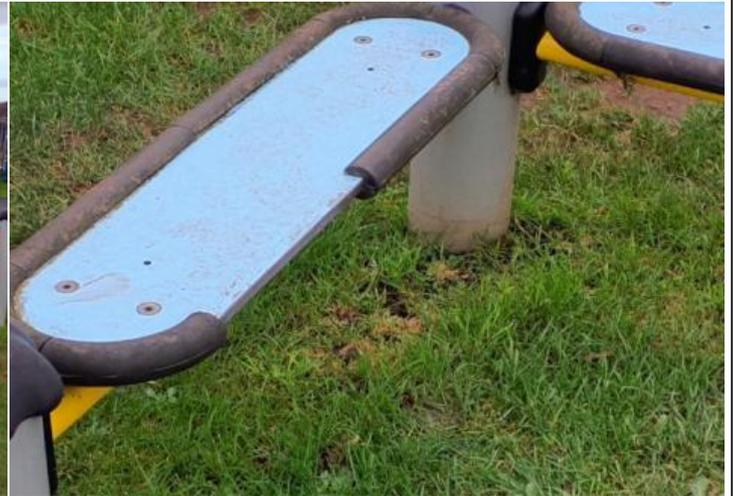
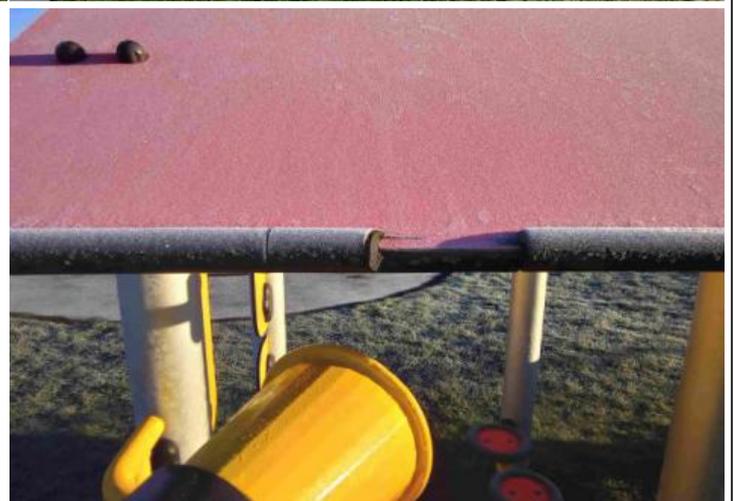
Finding: The rubber edgings are damaged or missing

Action: Replace the edgings as required

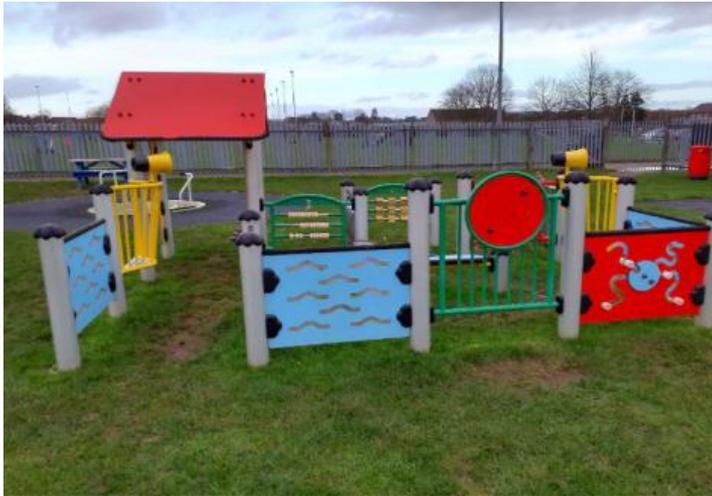
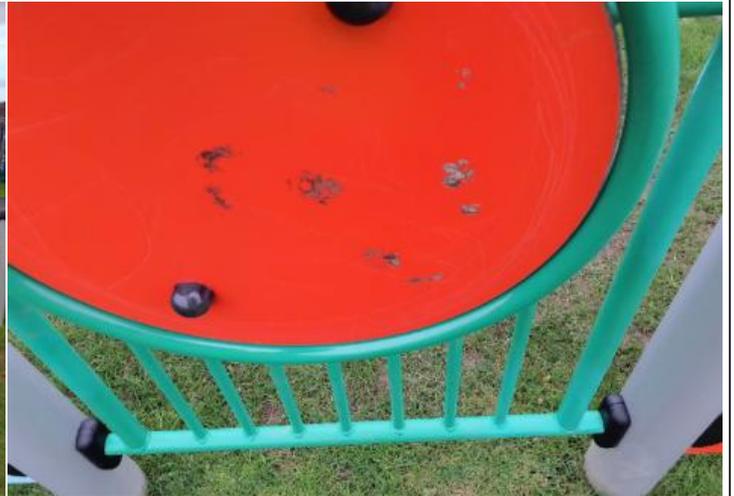
Finding: There is fire damage to the item

Action: Monitor for any further deterioration and repair as required

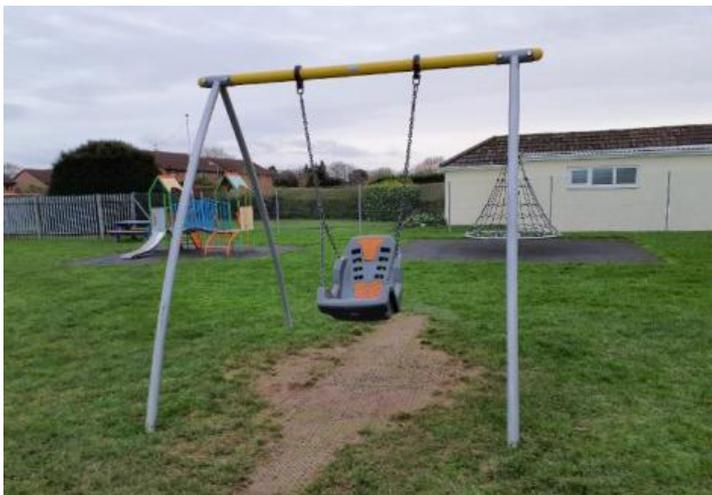
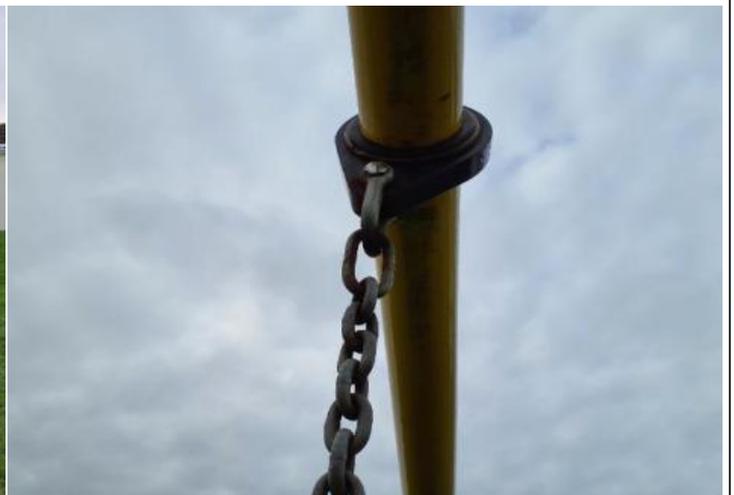
Finding: The shackles have been overtightened or seized transferring wear to the chain links below

Action: Loosen shackles to ensure free movement at the pivot

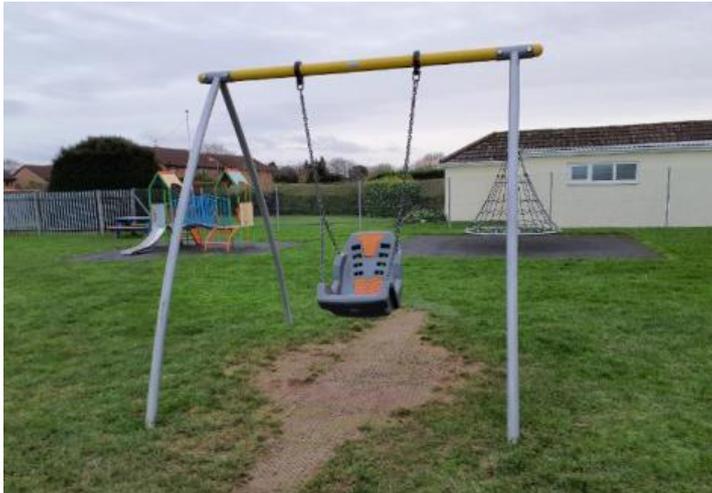
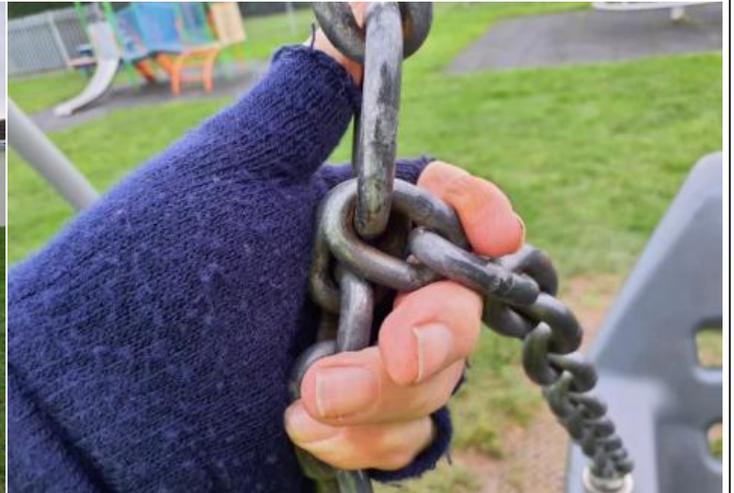
Finding: There is some notable evidence of chain wear

Action: Monitor for any further deterioration and replace when 40% worn

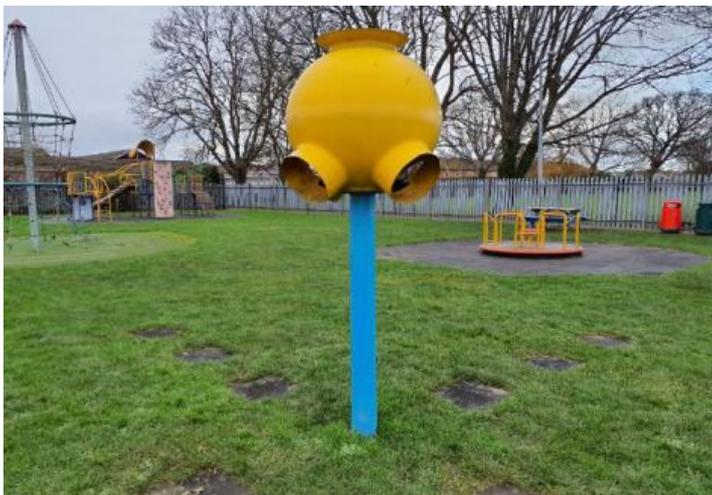
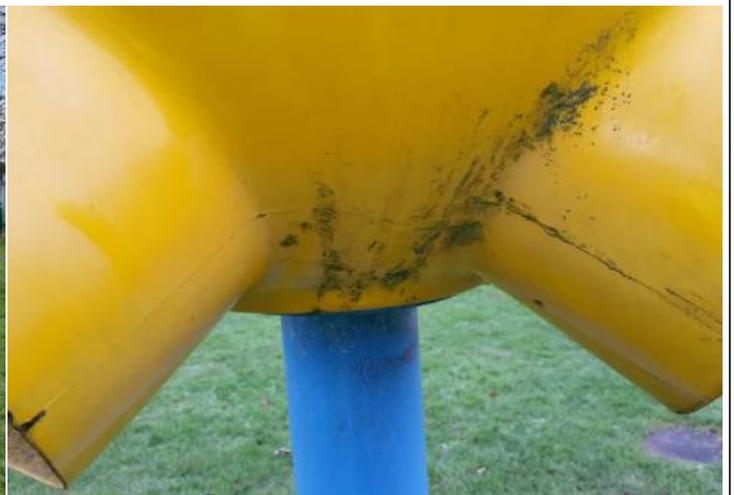
Finding: There is algae or moss on the surface of the equipment

Action: Clean and treat appropriately

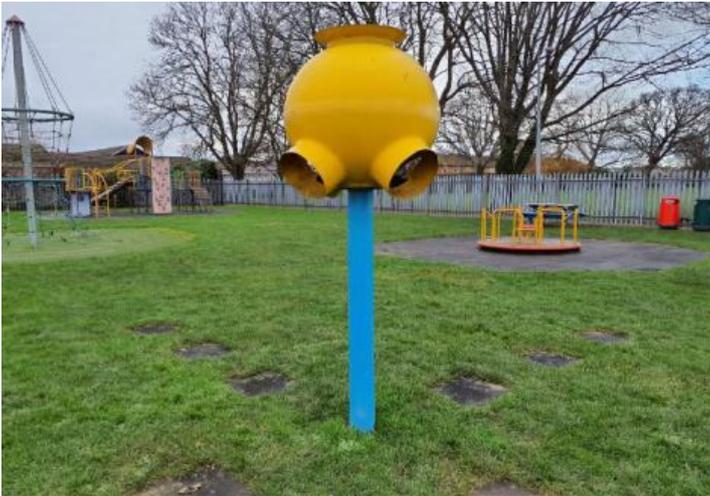
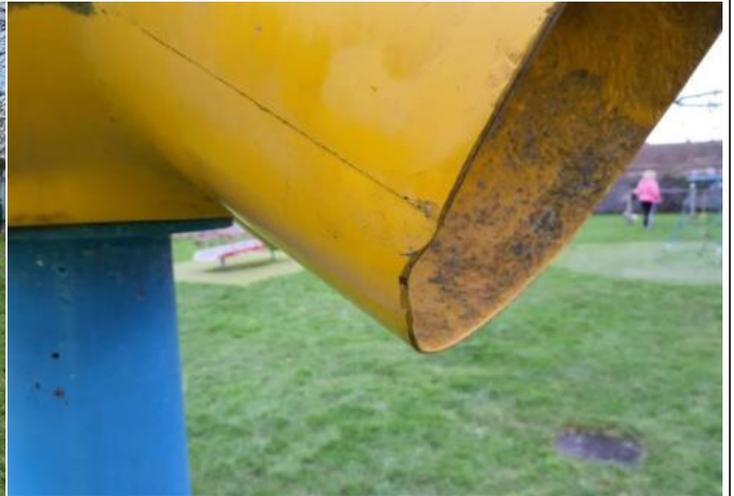
Finding: There is minor damage to the chute

Action: Monitor and repair if required

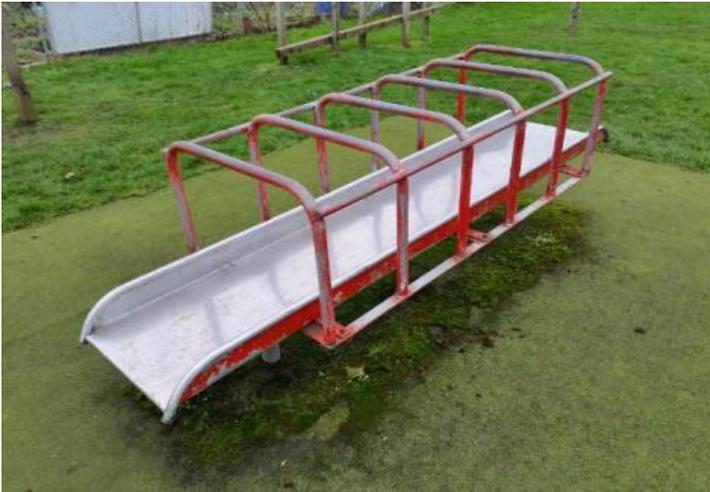
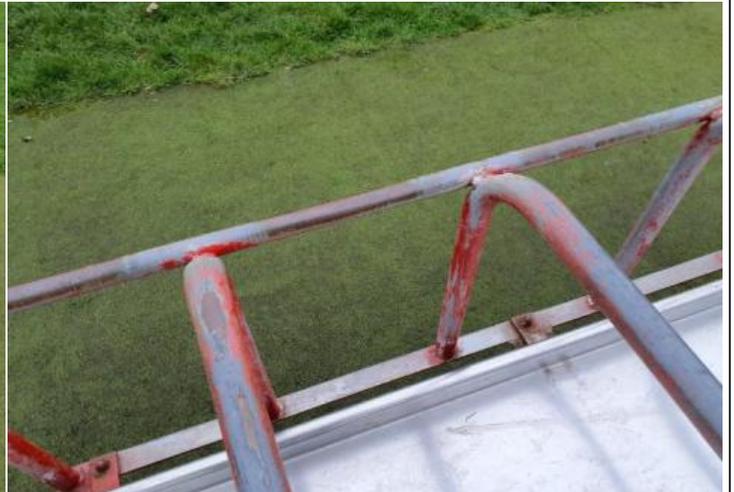
Finding: The paint is flaking off the metalwork

Action: Rub down and re-paint

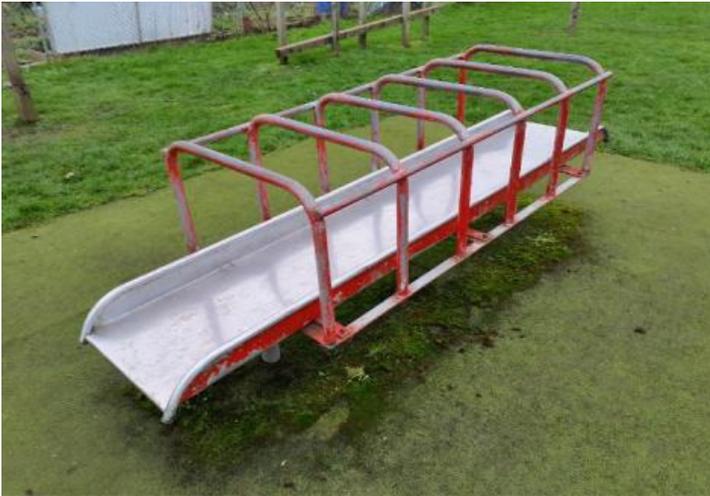
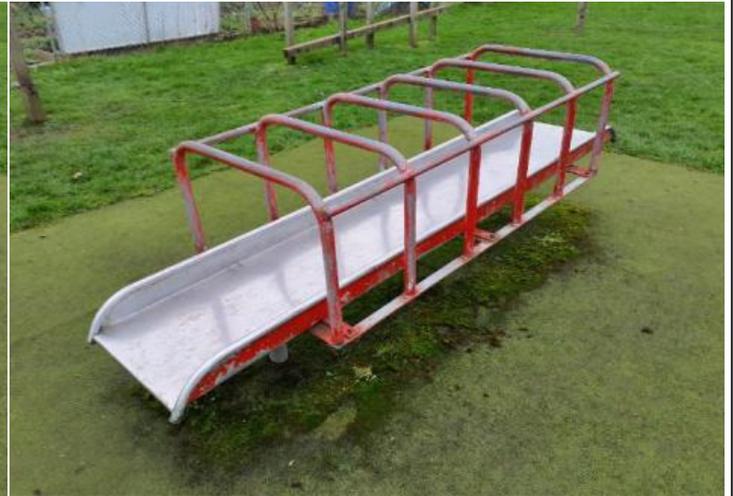
Finding: There is algae or moss growth on the surface resulting in slippery conditions

Action: Clean and treat appropriately

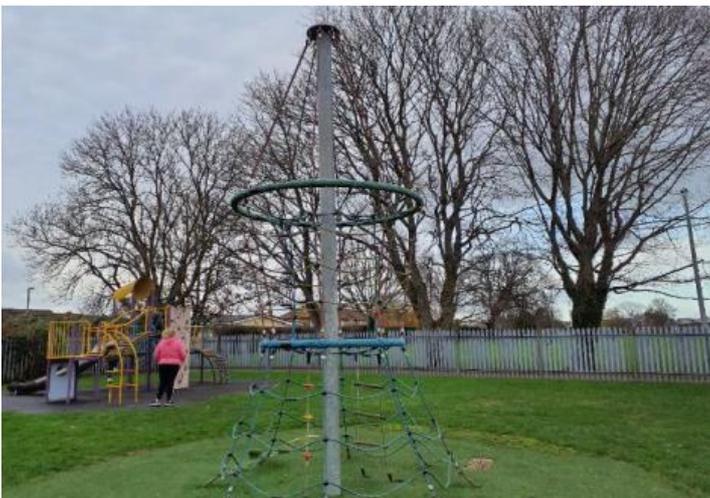
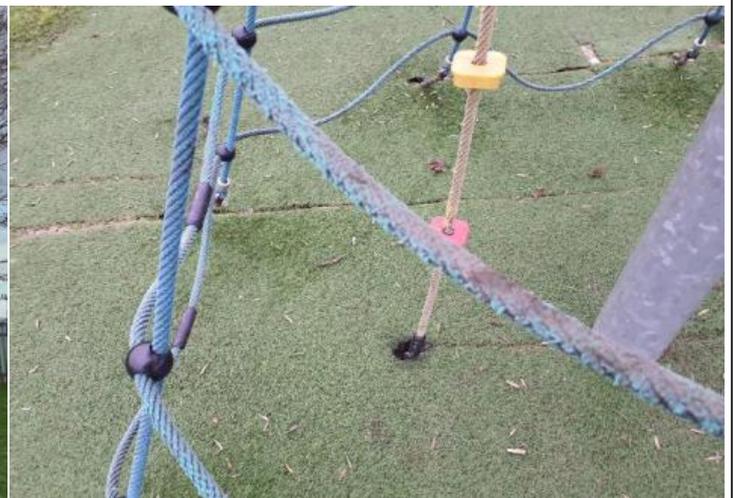
Finding: The rope has worn and wire strands are exposed

Action: Replace rope or net

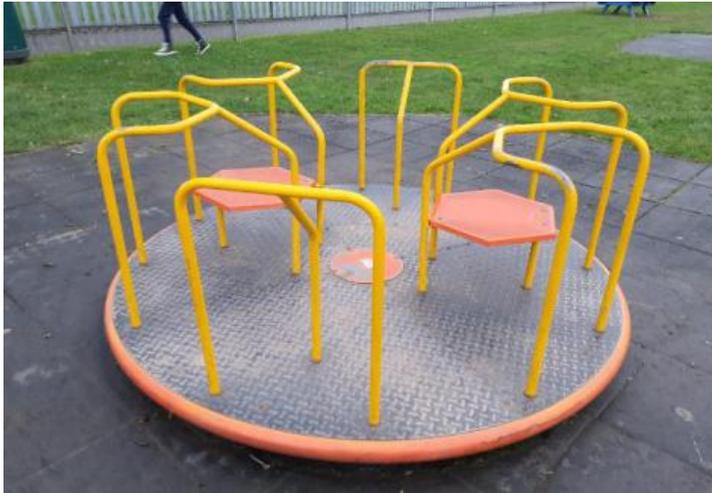
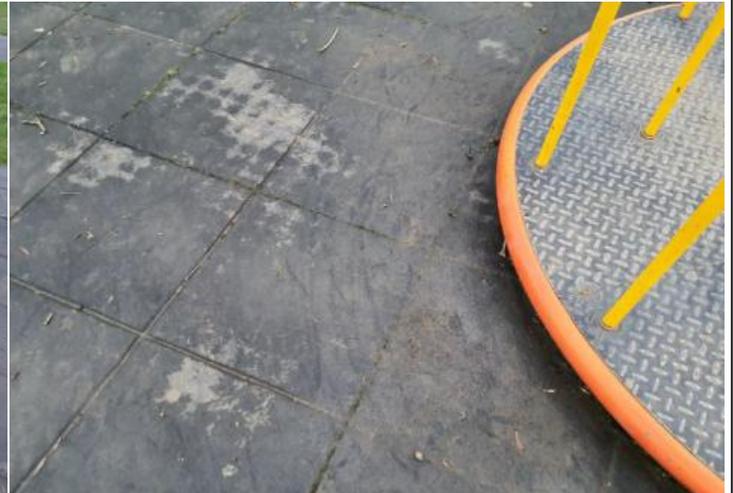
Finding: The safety surface around the area is beginning to wear

Action: Monitor for any further deterioration and repair as required

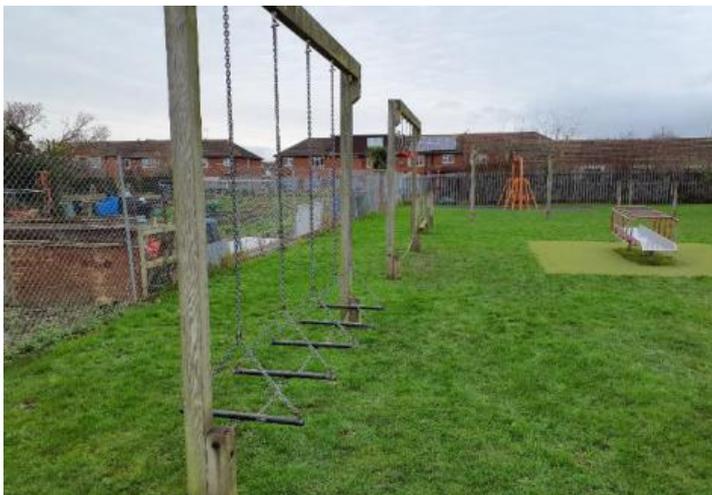
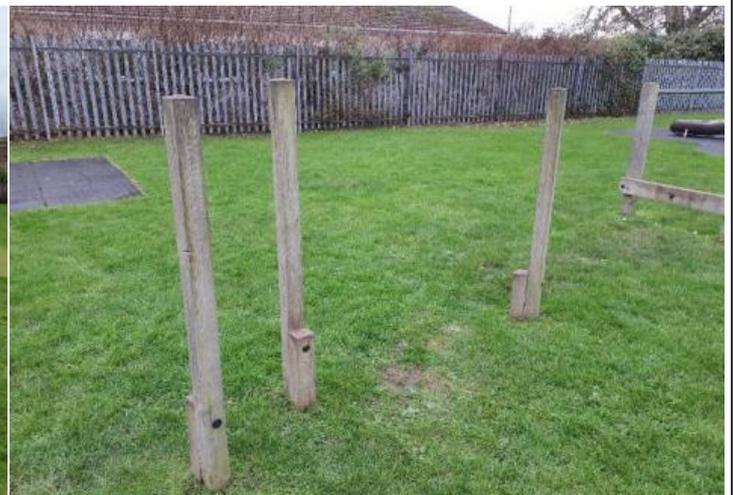
Finding: The item has missing component(s)

Action: Consider replacing missing components

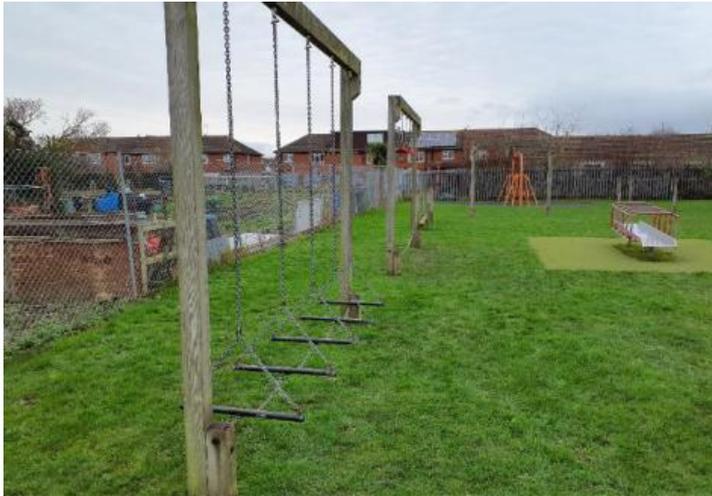
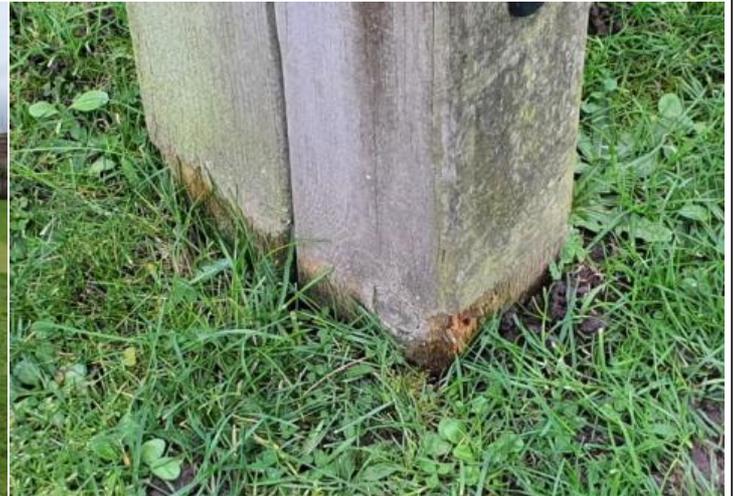
Finding: There is some strimmer / machinery damage apparent on the posts, this can penetrate the preservative applied to the timber and accelerate the rotting process

Action: Monitor for any deterioration (rot) and replace as required

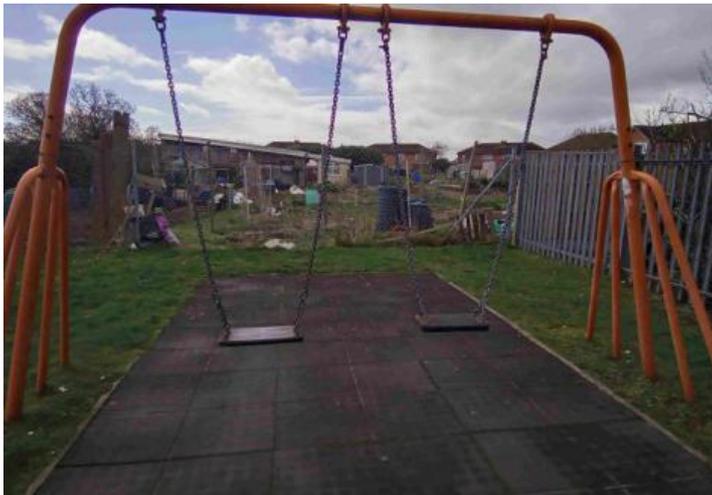
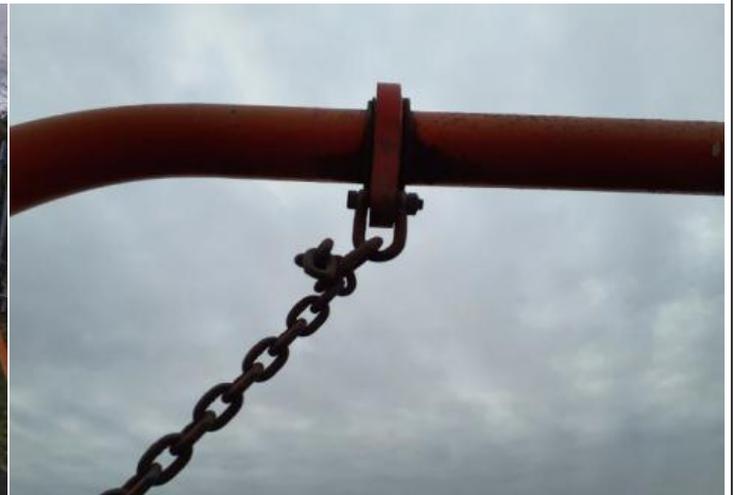
Finding: There is some wear to the shackles.

Action: Monitor for any further deterioration and replace when 40% worn

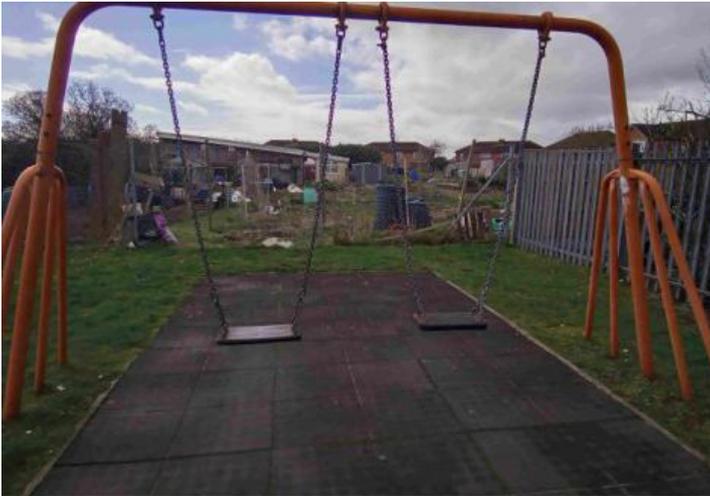
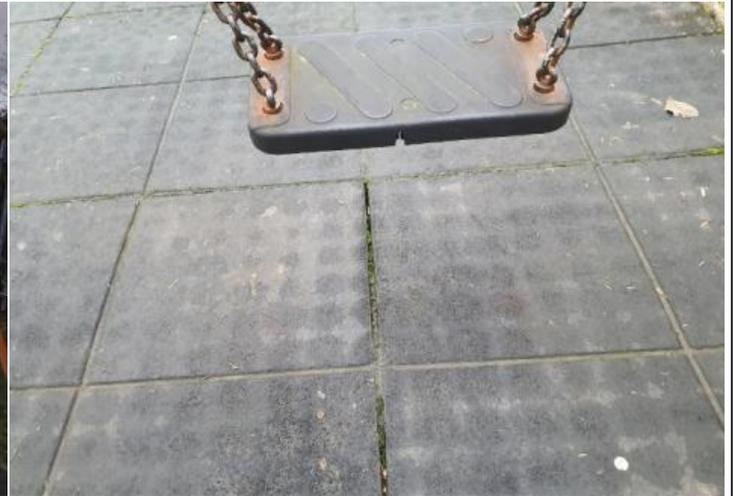
Finding: The seat has minor damage or wear

Action: Monitor for any further deterioration and replace as required

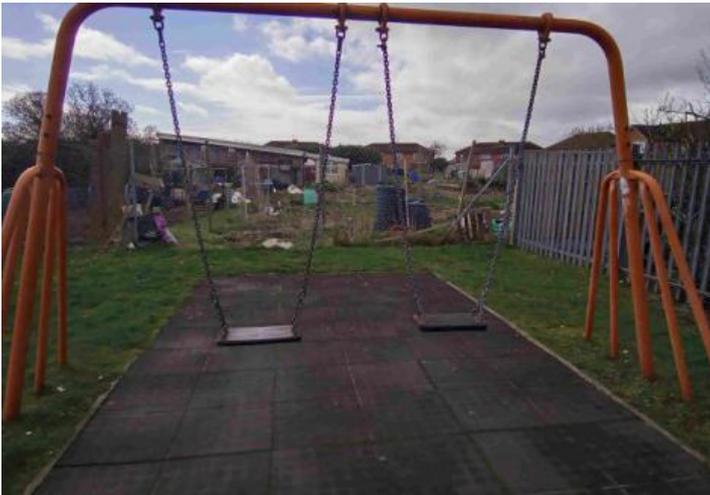
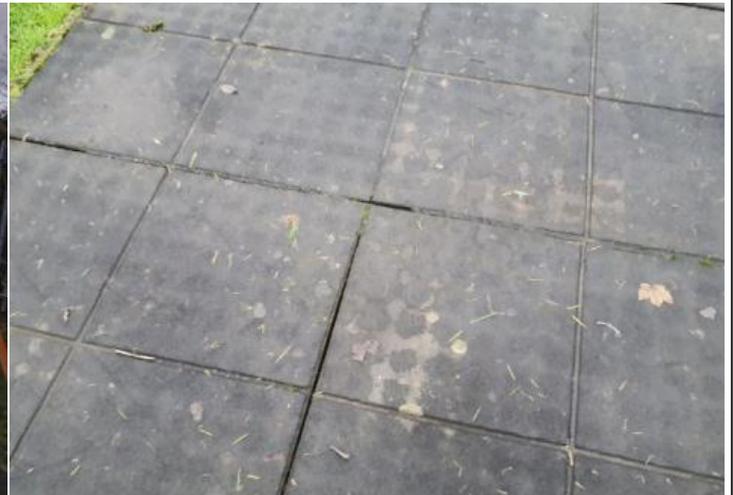
Finding: The safety surface around the area is beginning to wear

Action: Monitor for any further deterioration and repair as required

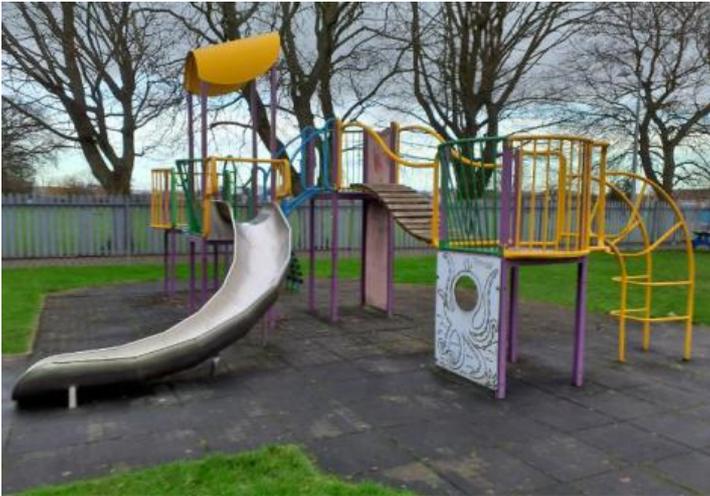
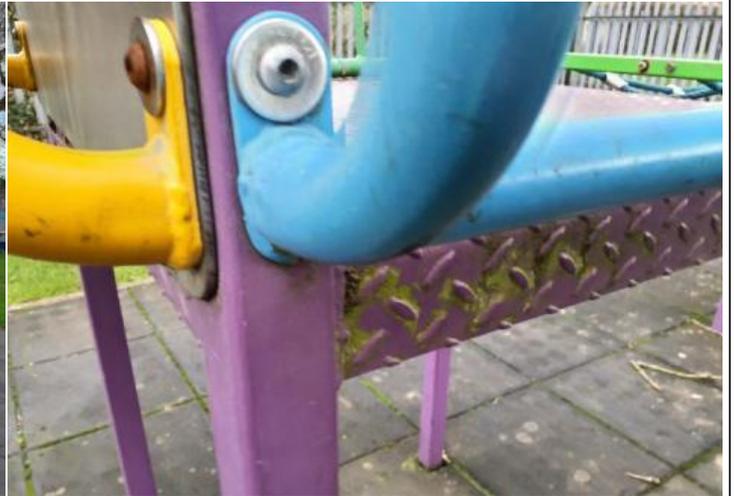
Finding: There is algae or moss on the surface of the equipment

Action: Clean and treat appropriately

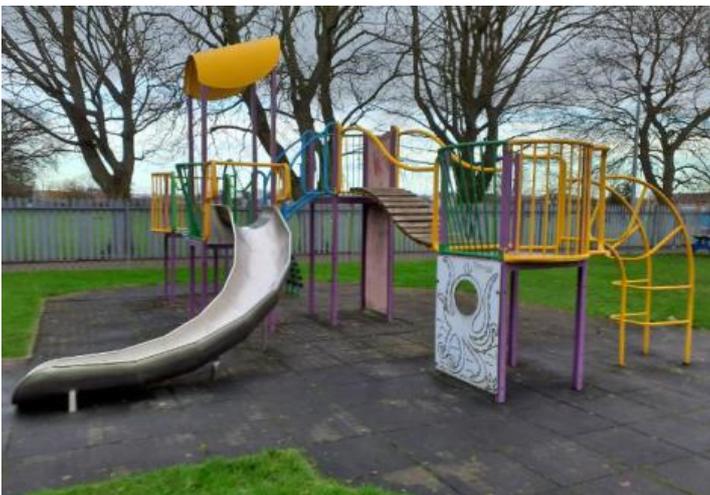
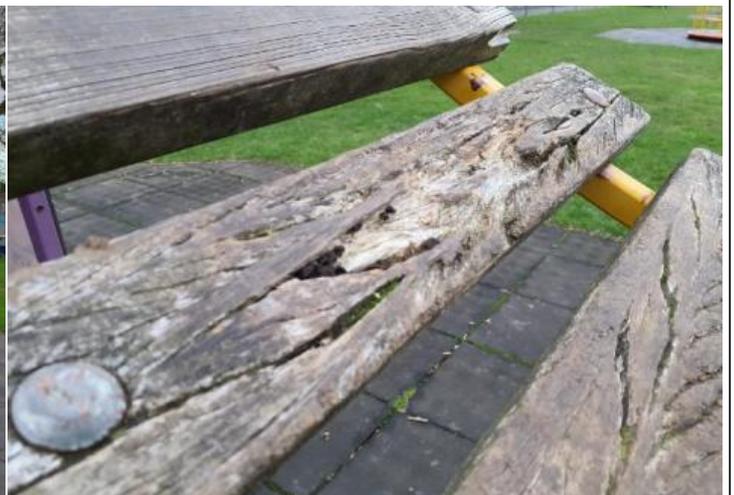
Finding: There is some evidence of rot in the timber

Action: Monitor for any further deterioration and replace as required

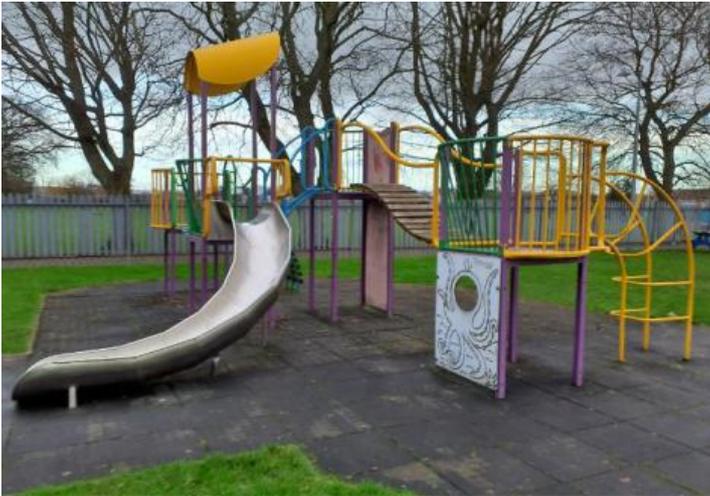
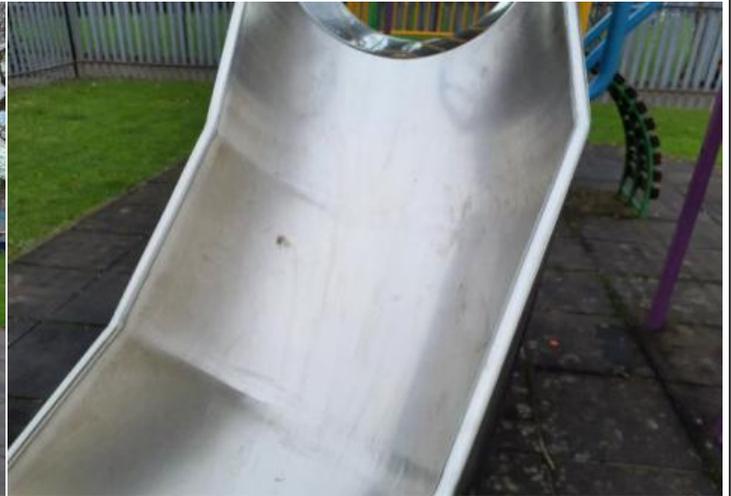
Finding: There are a number of dents in the slide surface

Action: Monitor for any further deterioration and repair as required

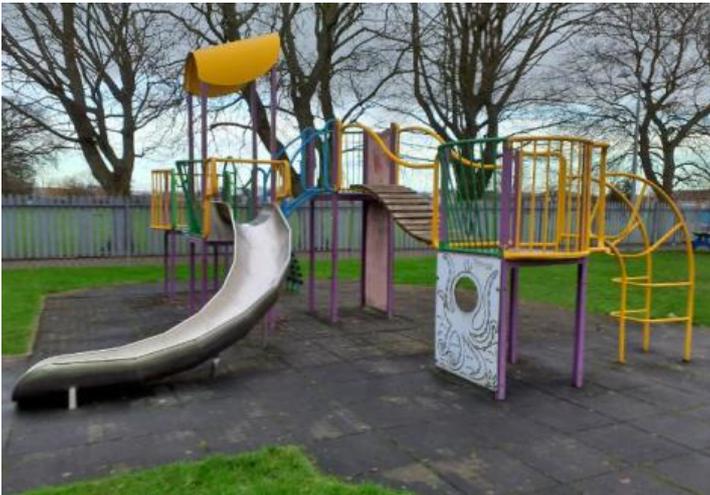
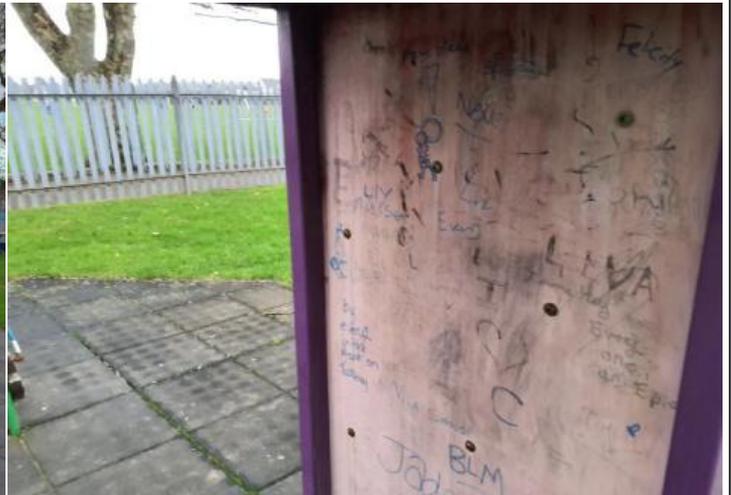
Finding: There is some graffiti present

Action: Remove the graffiti

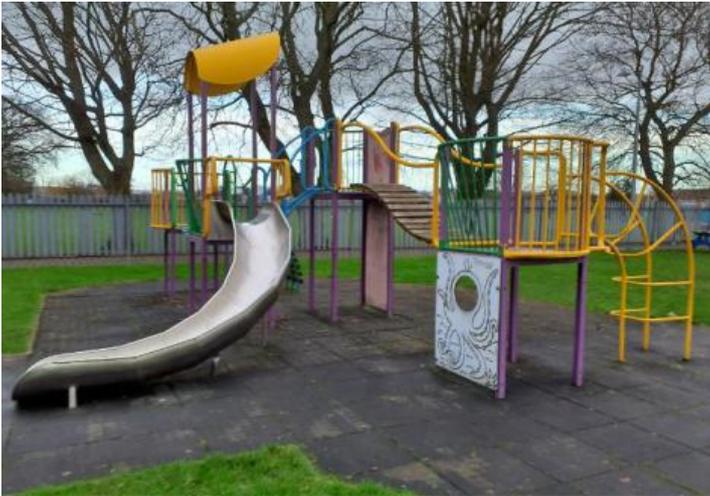
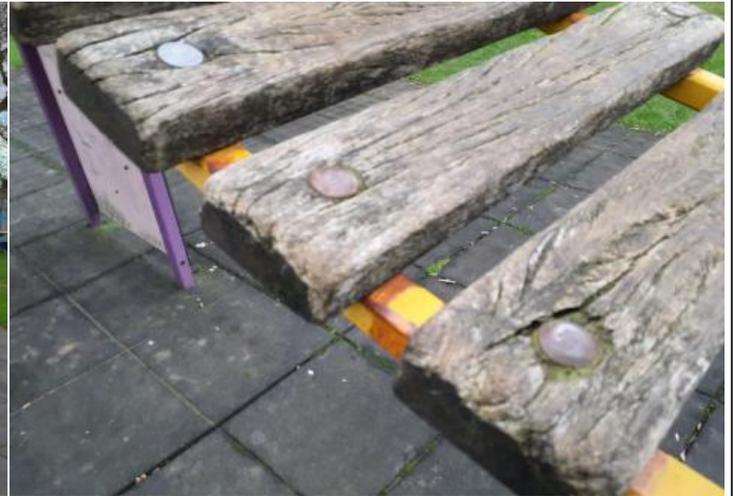
Finding: Parts of the timber are rough or splintered

Action: Remove all rough or sharp edges

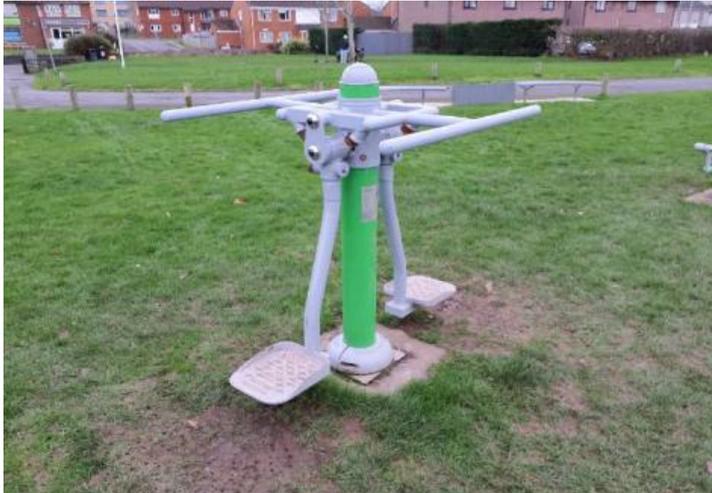
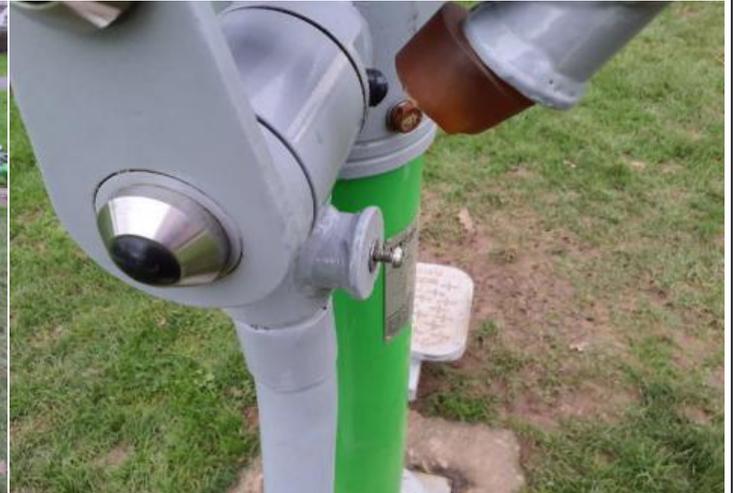
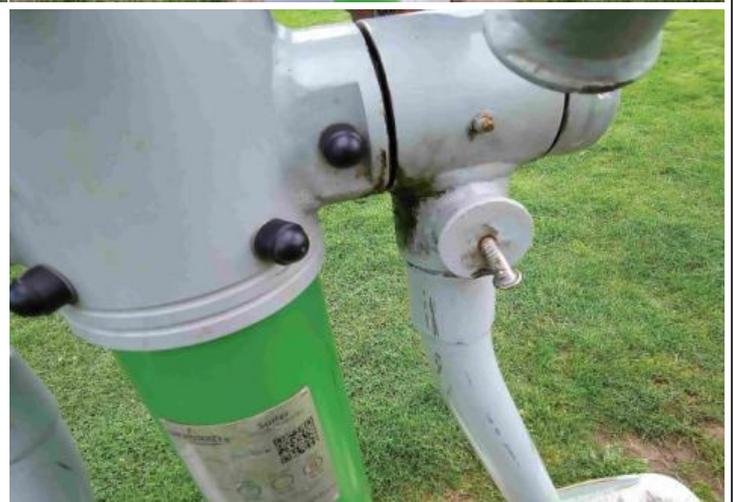
Finding: The buffers are worn or missing, 8 needed

Action: Replace the buffers as required

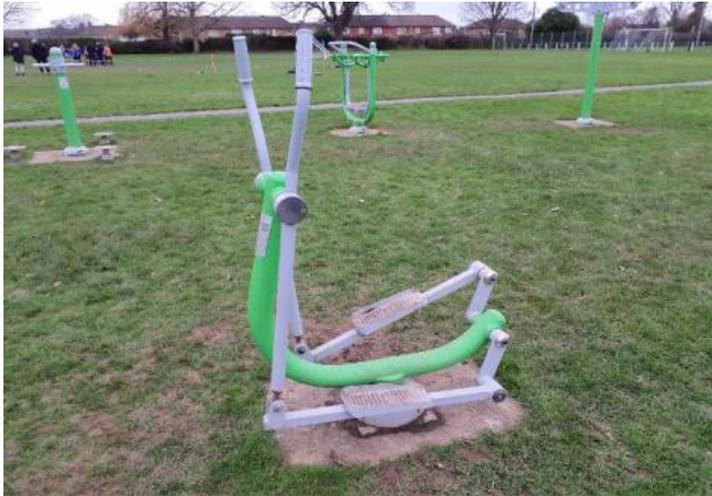
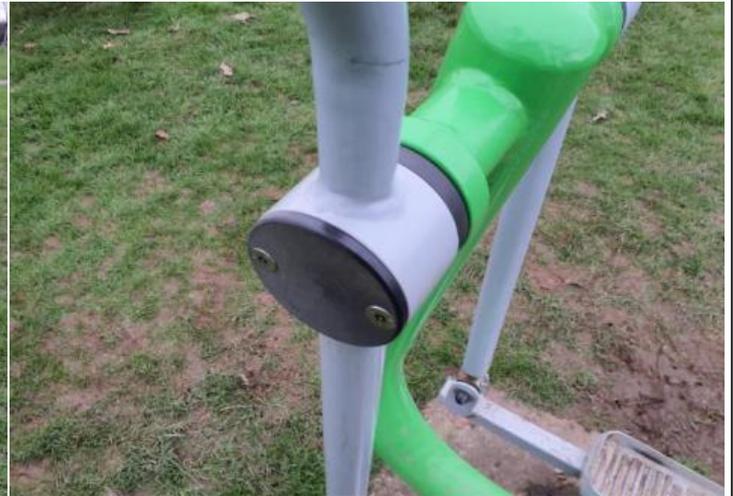
Finding: The bearing is showing signs of wear

Action: Monitor for any further deterioration and replace as required
