King George Playing Fields

Inspection Ref: 2269786

Operational Inspection - 18-January-2024 - 09:16 Inspector Matthew Meredith

Risk Assessment: 12 Moderate Risk

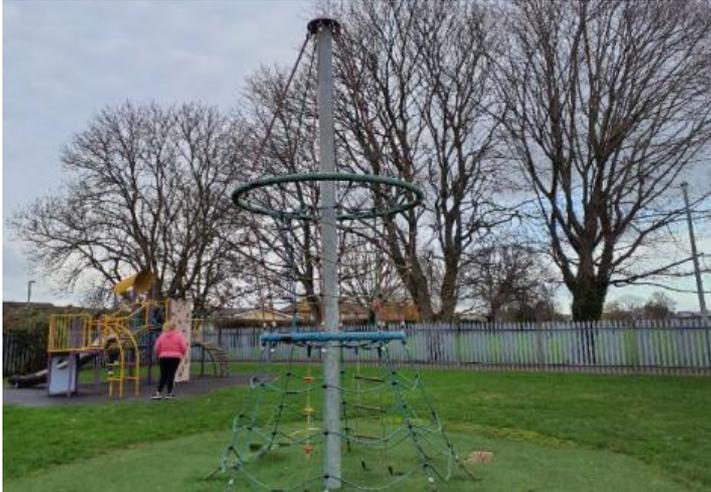
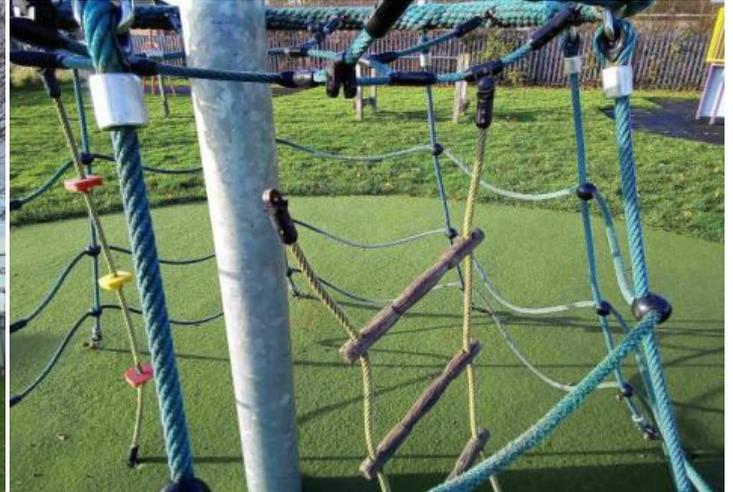
Finding: Fixings are damaged and/or have sharp edges

Action: Repair or replace as required
