LEGIONELLA RISK ASSESSMENT FOR

Caldicot Town Council Cyngor y Dref Cil-y-Coed

CALDICOT BOWLS CLUB

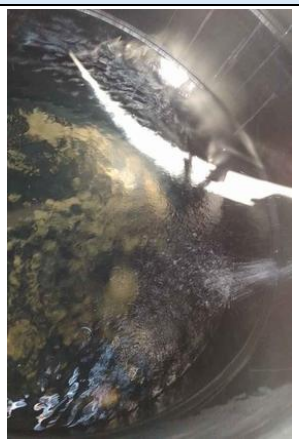
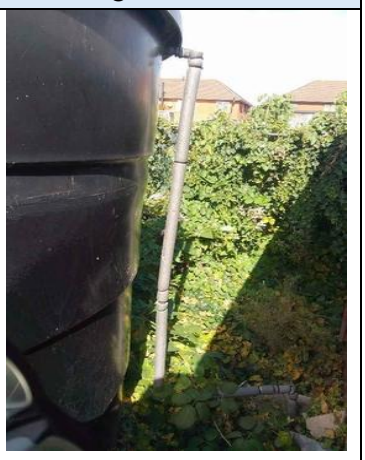
CWST01	Internal	Over flow pipe	Incoming mains

Building: Bowls pavilion		**Dimensions:** (metric)	
Tank Reference:	**CWST01**	Length:	1800
Location:	Outside pavilion	Width:	1800
Services / areas supplied:	Lawn irrigation system	Height:	2000
General accessibility:	Good	Capacity (litres) Nominal:	2000L
Internal Condition:		**Construction:**	
Internal tank condition:	Sediment	Material(s):	Plastic
Water appearance:	Clear	Lid material:	Plastic
Flotsam:	No	Lid fitting:	Secure
Smell:	No	Connected to other tanks	No
If multiple tanks are fitted in parallel, are they correctly balanced to avoid stagnation?	No	What is the external condition of the tank that could contaminate it when the lid is opened?	None
Suitable base present:	Yes	Insulation: (type / coverage)	CWST is double skinned
Warning Pipe Screen Fitted	No	Overflow screen fitted	No
Boosted supply?	Yes	Where booster pumps exist is there a duty/standby installation and does it have a system for manual weekly changeover or if automated all pumps have an operating cycle?	No – single pump

Temp – Inlet valve:	20.0	Vent pipe signs of discharge:	No
Temp – Stored:	20.0	Tank compliant :	No
Are there any hollow supports, or similar hollow structures?	No	Are there any flanges, cross braces, bolts or similar and what is their condition?	N/A
Presumed flow rate:	<24hrs over the bowls season or non-rainy months	**RISK RATING:**	**LOW**
Comments:

Annually inspect and if required clean and disinfect the tank and its associated down services as per HSG 274 Part 2 and BS EN 806:2010. Tank did have sediment in the bottom which should be removed.	**HIGH**	
The tank was found to be non-compliant with current water fittings regulations, the following items were identified: • Screened lid vent missing • Screened overflow / warning pipe missing • Lack of tank insulation.	**MEDIUM**	
Hot & Cold Services	**Priority**	**Completion date**
Remove all dead ends/ Dead legs back to spur or install suitable device to allow regular flushing. See section 6.4.	**HIGH**	
Fit signage in WC's to notify building users to close toilet seats before flushing to minimise any potential risk of exposure to contaminated legionella droplets from toilet cisterns.	**LOW**	
Insulate all exposed areas of pipework to avoid heat loss or gain, e.g. hot runs above cold pipework and runs near radiators where applicable.	**LOW**
