King George Playing Fields

Inspection Ref: 2269786

Operational Inspection - 18-January-2024 - 09:16 Inspector Matthew Meredith

Risk Assessment: 12 Moderate Risk

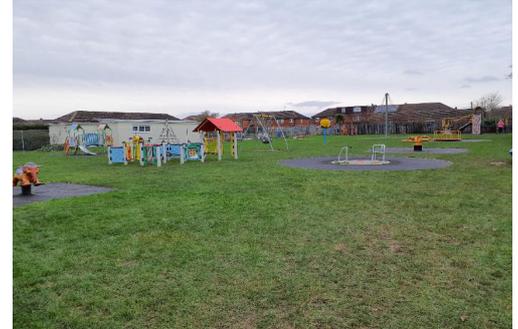
Item: Site General
Manufacturer: Not Applicable
Surface Type: N/A
Item Quantity: 1
Equipment Compliance: N/A
Surface Area Compliance: N/A

There is algae or moss growth on the tiled surface resulting in slippery conditions - Clean and treat appropriately

The grass mats are silted up and the soil is compacted; this may have an effect on the impact absorbing properties of the surface - Consider HIC testing impact absorbing properties to ensure the correct surface qualities are maintained for the equipment and replace as required

There are gaps opening in between the tiles - Monitor for any further deterioration and repair as required

Finding: There is algae or moss growth on the tiled surface resulting in slippery conditions
Action: Clean and treat appropriately

Action: Consider HIC testing impact absorbing properties to ensure the correct surface qualities are maintained for the equipment and replace as required

Action: Monitor for any further deterioration and repair as required

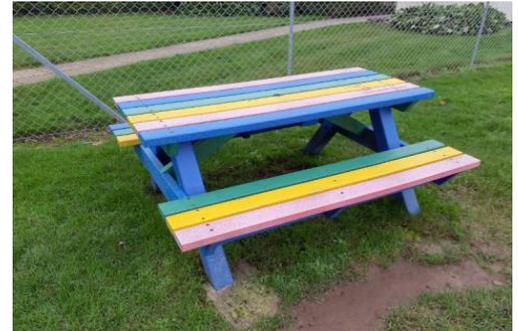
Item: Picnic Table
Manufacturer: Not Identified
Surface Type: Grass
Item Quantity: 4
Equipment Compliance: N/A
Surface Area Compliance: N/A

The area around the item has eroded and may become slippery - Reinstate eroded area

There is some graffiti present - Remove the graffiti

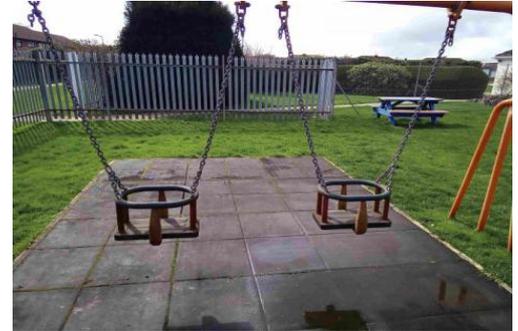
Item: 1 Bay 2 Seat (Cradle)
Manufacturer: Wicksteed Playgrounds
Surface Type: Rubber Tiles
Item Quantity: 1
Equipment Compliance: No
Surface Area Compliance: Yes

There is some wear to the shackles. - Monitor for any further deterioration and replace when 40% worn

Finding: There is some wear to the shackles.

Action: Monitor for any further deterioration and replace when 40% worn

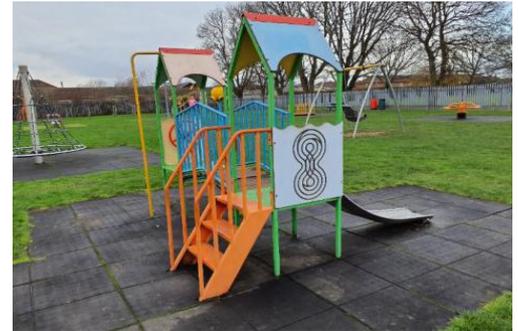
Item: Multi Play (Toddler)
Manufacturer: Wicksteed Playgrounds
Surface Type: Rubber Tiles
Item Quantity: 1
Equipment Compliance: No
Surface Area Compliance: Yes

There is some graffiti present - Remove the graffiti

There are a number of dents in the slide surface - Monitor for any further deterioration and repair as required

Action: Monitor for any further deterioration and repair as required

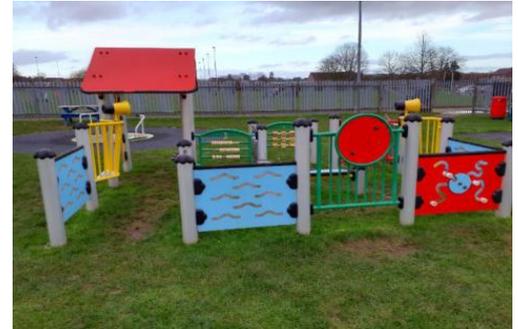
Item: Play Panel
Manufacturer: Sutcliffe Play Limited
Surface Type: Grass Matrix Tiles
Item Quantity: 1
Equipment Compliance: No
Surface Area Compliance: N/A

The rubber edgings are damaged or missing - Replace the edgings as required

There is fire damage to the item - Monitor for any further deterioration and repair as required

Finding: The rubber edgings are damaged or missing

Finding: There is fire damage to the item

Action: Replace the edgings as required

Action: Monitor for any further deterioration and repair as required

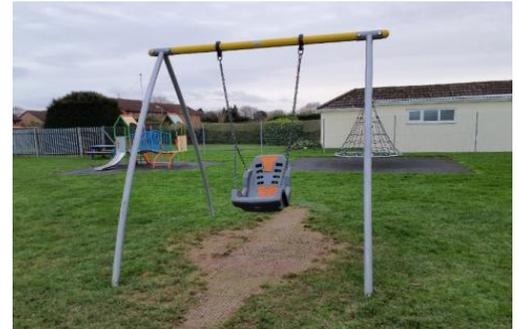
Item: 1 Bay 1 Seat Swing
Manufacturer: Wicksteed Playgrounds
Surface Type: Grass Matrix Tiles
Item Quantity: 1
Equipment Compliance: No
Surface Area Compliance: Yes

The shackles have been overtightened or seized transferring wear to the chain links below - Loosen shackles to ensure free movement at the pivot

There is some notable evidence of chain wear - Monitor for any further deterioration and replace when 40% worn

Finding: The shackles have been overtightened or seized transferring wear to the chain links below

Finding: There is some notable evidence of chain wear

Action: Loosen shackles to ensure free movement at the pivot

Action: Monitor for any further deterioration and replace when 40% worn

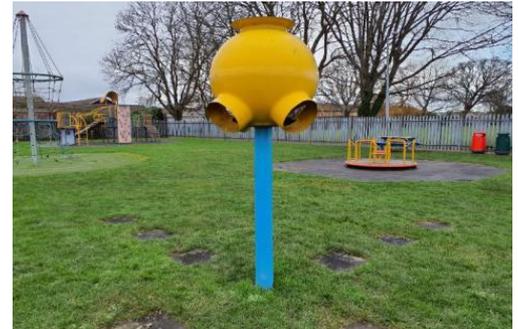
Item: Ball Shoot
Manufacturer: Wicksteed Playgrounds
Surface Type: Mixed Surface
Item Quantity: 1
Equipment Compliance: Yes
Surface Area Compliance: N/A

There is algae or moss on the surface of the equipment -
 Clean and treat appropriately

There is minor damage to the chute - Monitor and repair if
 required

Finding: There is minor damage to the chute

Action: Monitor and repair if required

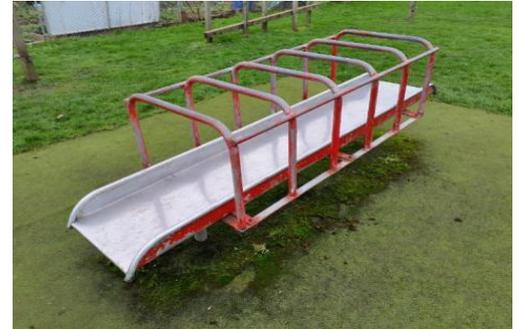
Item: Crawling Tunnel
Manufacturer: Not Identified
Surface Type: Carpet System
Item Quantity: 1
Equipment Compliance: Yes
Surface Area Compliance: Yes

The paint is flaking off the metalwork - Rub down and re-paint

There is algae or moss growth on the surface resulting in slippery conditions - Clean and treat appropriately

Finding: There is algae or moss growth on the surface resulting in slippery conditions

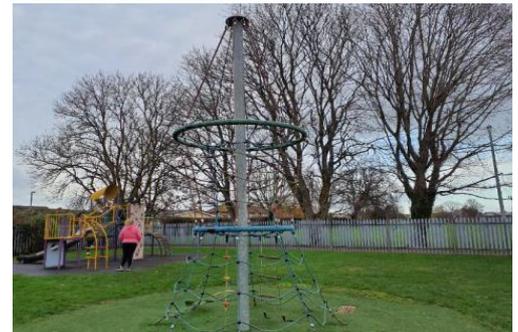
Item: Net Climber
Manufacturer: Huck Nets (UK) Ltd
Surface Type: Carpet System
Item Quantity: 1
Equipment Compliance: Yes
Surface Area Compliance: Yes

The rope has worn and wire strands are exposed - Replace rope or net

Finding: The rope has worn and wire strands are exposed

Action: Replace rope or net

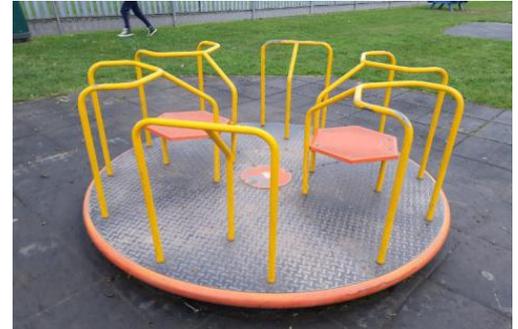
Item: Roundabout
Manufacturer: Wicksteed Playgrounds
Surface Type: Rubber Tiles
Item Quantity: 1
Equipment Compliance: Yes
Surface Area Compliance: Yes

The safety surface around the area is beginning to wear - Monitor for any further deterioration and repair as required

Finding: The safety surface around the area is beginning to wear

Action: Monitor for any further deterioration and repair as required

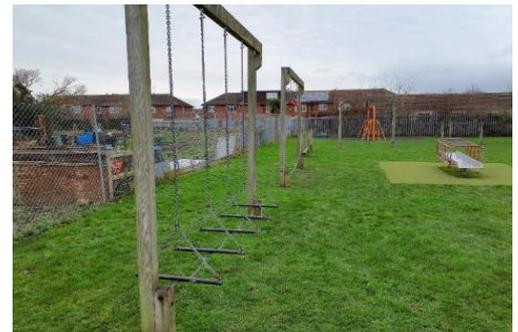
Item: Adventure Trail
Manufacturer: Not Identified
Surface Type: Grass
Item Quantity: 1
Equipment Compliance: No
Surface Area Compliance: Yes

The item has missing component(s) - Consider replacing missing components

There is some strimmer / machinery damage apparent on the posts, this can penetrate the preservative applied to the timber and accelerate the rotting process - Monitor for any deterioration (rot) and replace as required

Finding: The item has missing component(s)

Finding: There is some strimmer / machinery damage apparent on the posts, this can penetrate the preservative applied to the timber and accelerate the rotting process

Action: Consider replacing missing components

Action: Monitor for any deterioration (rot) and replace as required

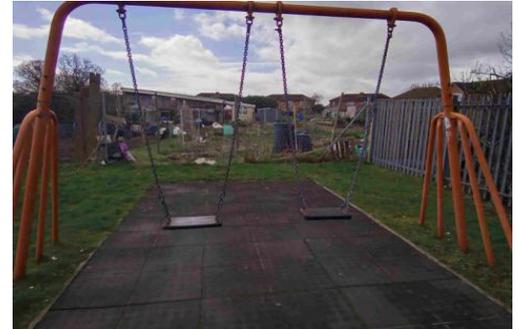
Item: 1 Bay 2 Seat (Flat)
Manufacturer: Wicksteed Playgrounds
Surface Type: Rubber Tiles
Item Quantity: 1
Equipment Compliance: No
Surface Area Compliance: Yes

There is some wear to the shackles. - Monitor for any further deterioration and replace when 40% worn

The seat has minor damage or wear - Monitor for any further deterioration and replace as required

The safety surface around the area is beginning to wear - Monitor for any further deterioration and repair as required

Finding: There is some wear to the shackles.

Finding: The seat has minor damage or wear

Finding: The safety surface around the area is beginning to wear

Action: Monitor for any further deterioration and replace when 40% worn

Action: Monitor for any further deterioration and replace as required

Action: Monitor for any further deterioration and repair as required

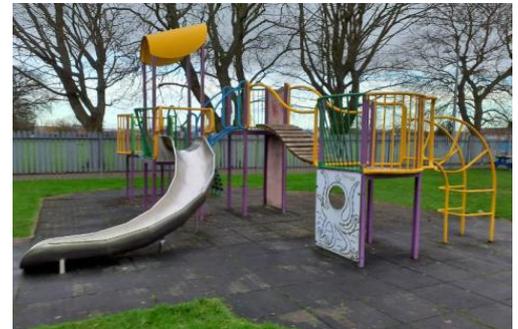
Item: Multi Play (Junior)
Manufacturer: Wicksteed Playgrounds
Surface Type: Rubber Tiles
Item Quantity: 1
Equipment Compliance: No
Surface Area Compliance: Yes

There is algae or moss on the surface of the equipment - Clean and treat appropriately

There is some evidence of rot in the timber - Monitor for any further deterioration and replace as required

There are a number of dents in the slide surface - Monitor for any further deterioration and repair as required

There is some graffiti present - Remove the graffiti

Parts of the timber are rough or splintered - Remove all rough or sharp edges

Finding: There is some evidence of rot in the timber

Action: Monitor for any further deterioration and replace as required

Action: Monitor for any further deterioration and repair as required

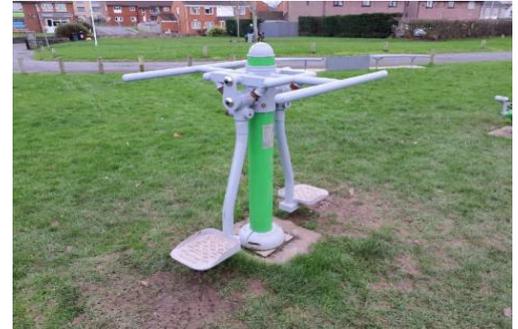
Item: Air Skier
Manufacturer: Wicksteed Playgrounds
Surface Type: Concrete
Item Quantity: 1
Equipment Compliance: No
Surface Area Compliance: N/A

The buffers are worn or missing, 8 needed - Replace the buffers as required

Finding: The buffers are worn or missing, 8 needed

Action: Replace the buffers as required

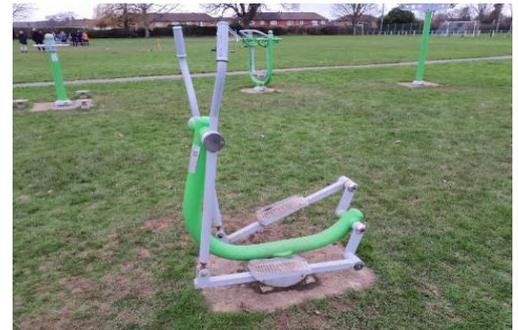
Item: Cross Trainer
Manufacturer: Wicksteed Playgrounds
Surface Type: Concrete
Item Quantity: 1
Equipment Compliance: No
Surface Area Compliance: N/A

The bearing is showing signs of wear - Monitor for any further deterioration and replace as required

Finding: The bearing is showing signs of wear

Action: Monitor for any further deterioration and replace as required
